TS 159125
PIC/JR-1027/61
June 1961

JOINT PHOTOGRAPHIC INTELLIGENCE REPORT

CONSTRUCTION ACTIVITY AT HERRINGBONE SAM FACILITIES MOSCOW, USSR

NATIONAL PHOTOGRAPHIC INTERPRETATION CENTER

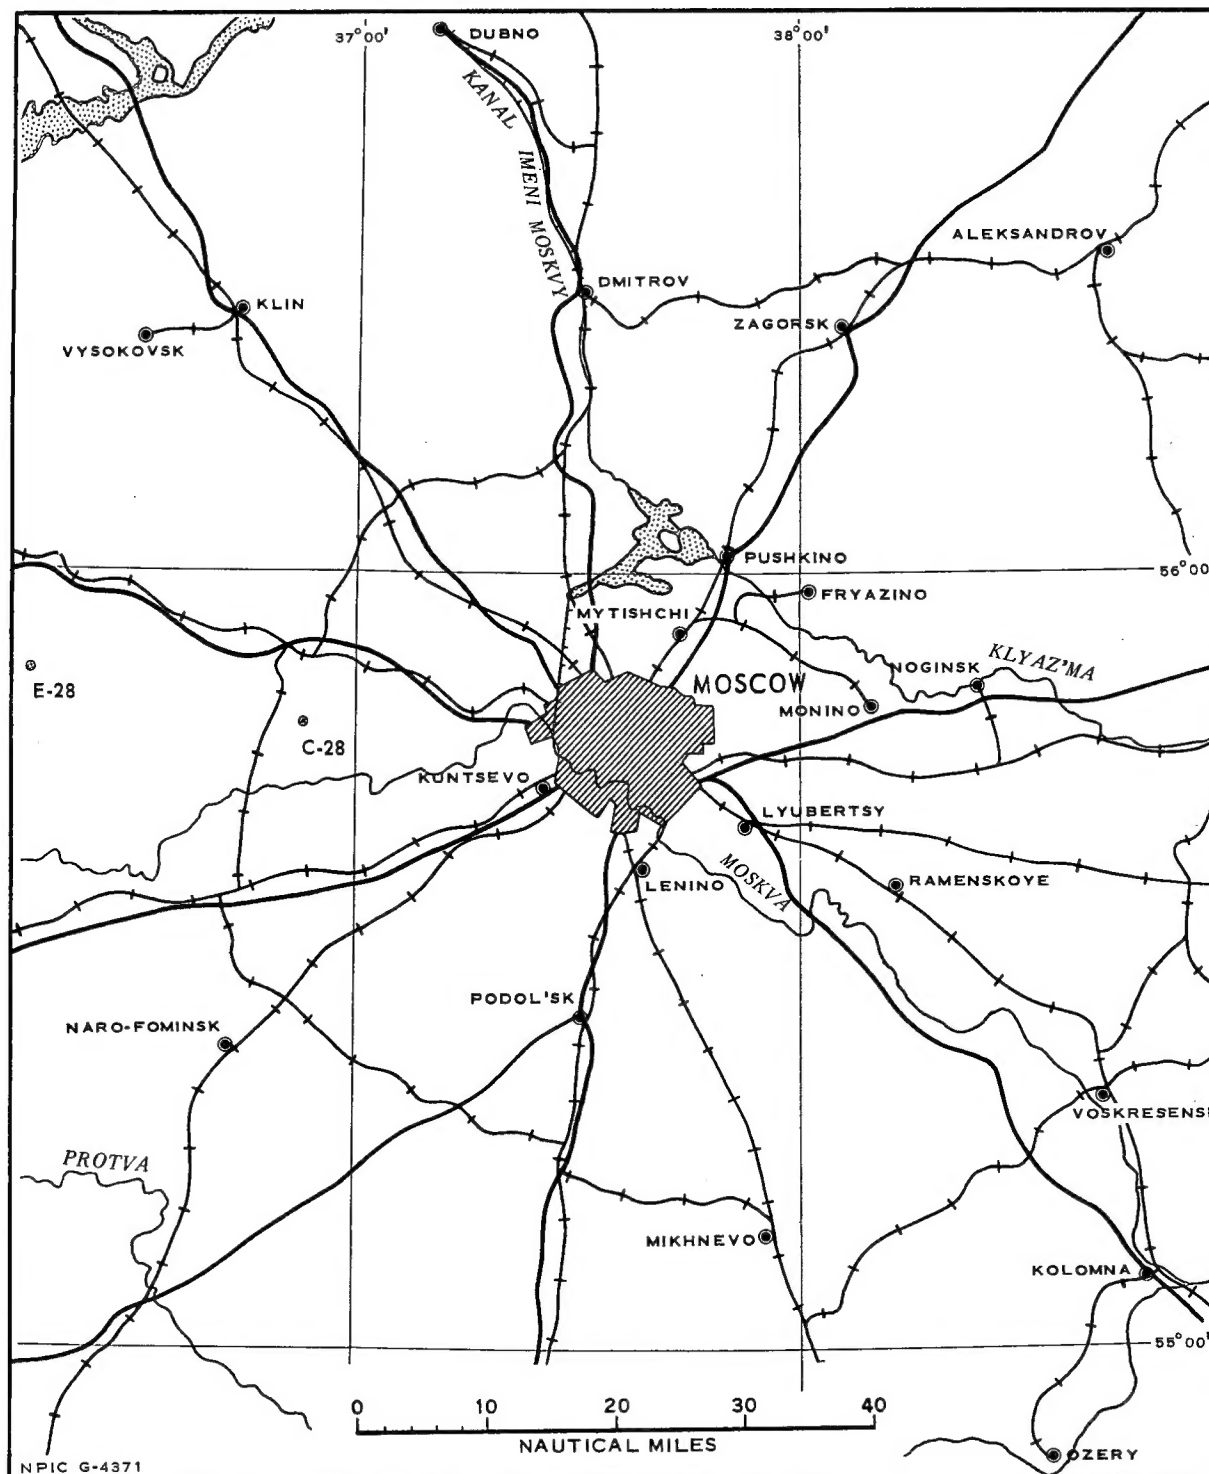
LOCATION OF MOSCOW SAM SITES C-28 AND E-28

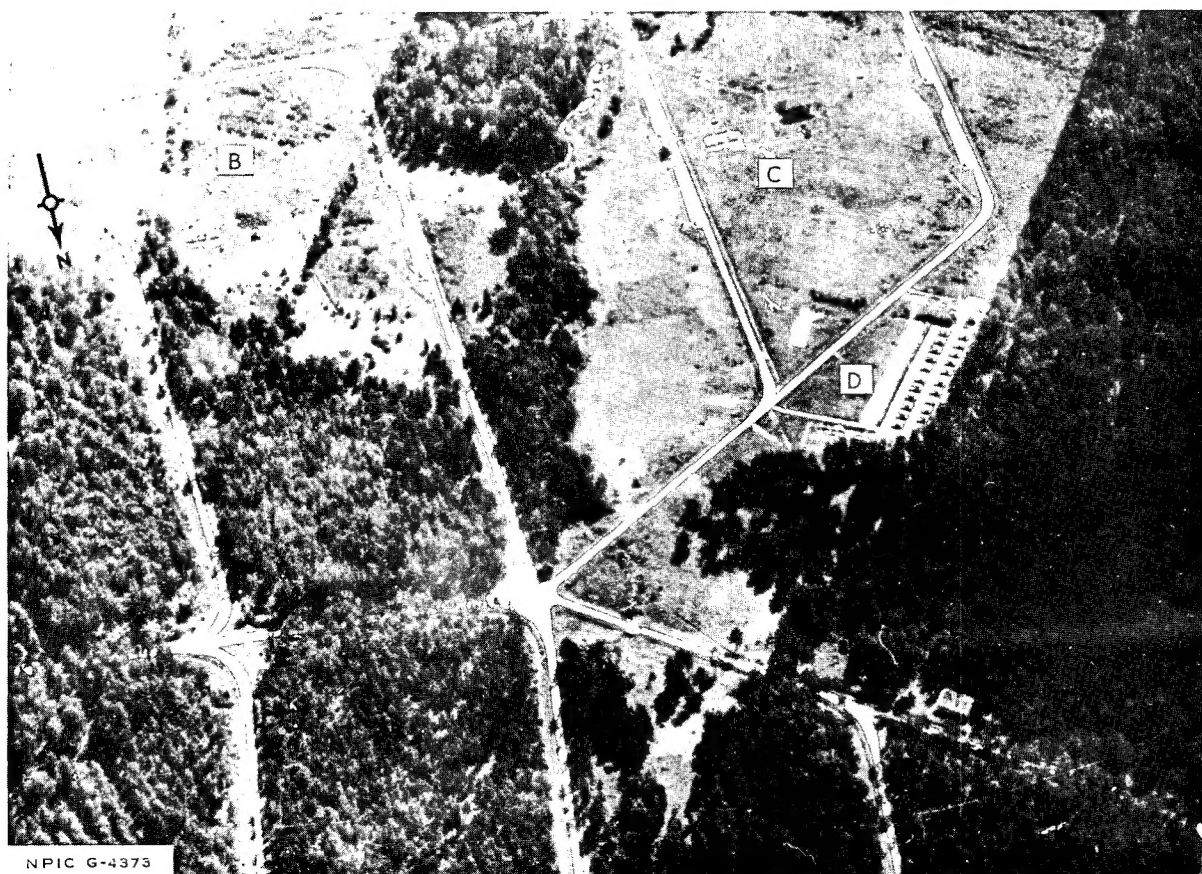
FIGURE 2. PORTION OF SAM SITE C-28. This shows new construction (items B, C, and D) as it appeared on photography.

earthen, [REDACTED] square and not more than [REDACTED] high. They are aligned end-to-end [REDACTED] apart and placed parallel and adjacent to a path that leads from an entrance in the side of the bunker to the adjacent launch road. The central portion of the top of each foundation is probably surfaced with gravel or concrete. A narrow graveled or concrete apron surrounds the group. Items B and C (Figures 1 and 2) are similar in appearance and construction and are also located between launch roads.

Item D, 22 tents, each approximately [REDACTED] square and arranged in parallel rows of 11 each, is located at the outer edge of the V-shaped end of the herringbone pattern adjacent to one of the service roads (Figures 1 and 2). At the end of each row there is a structure similar to the tents, though slightly taller. The area adjacent to the tents is paved and connected to the nearest road in the herringbone pattern by two narrow paths. Item D is probably a camp for troops in training at site C-28.

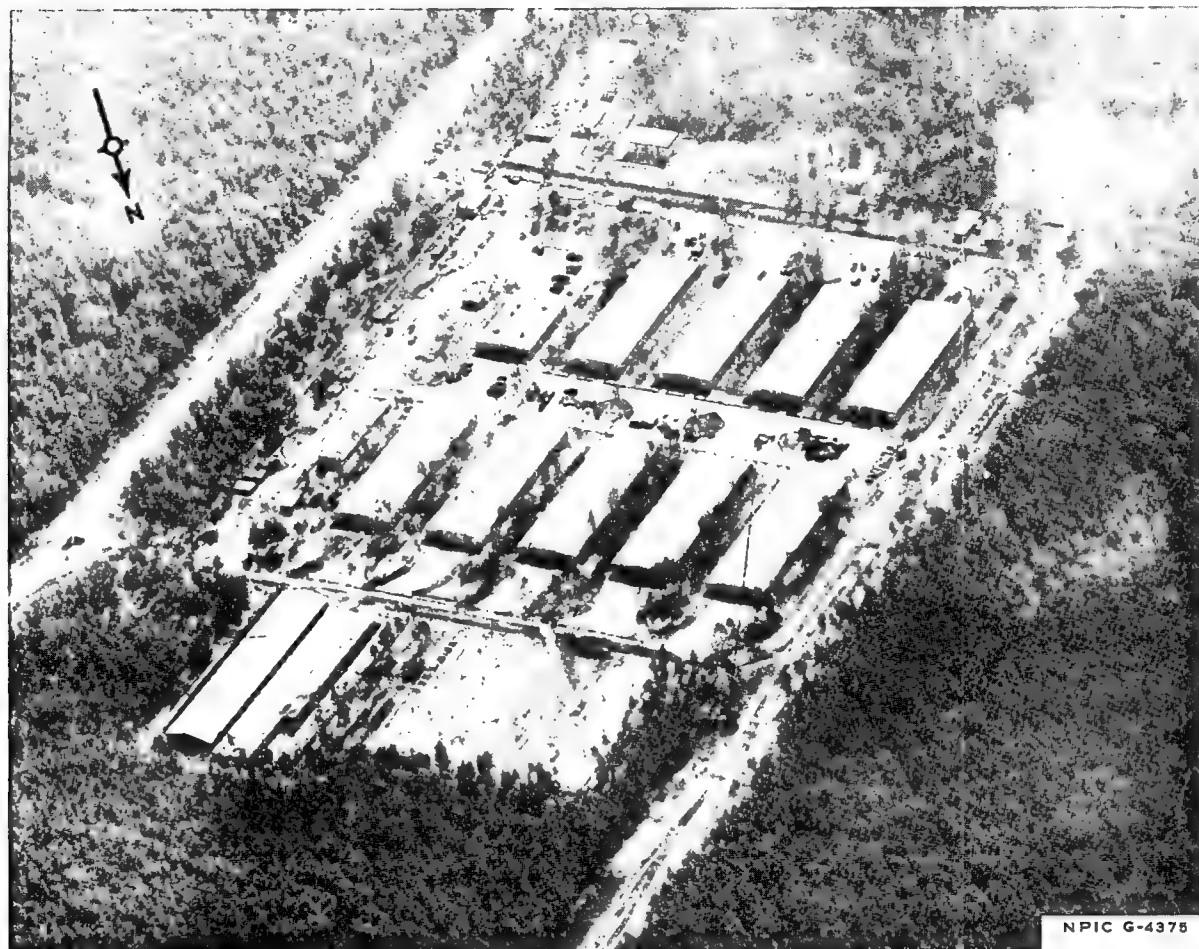
FIGURE 4. STORAGE AREA NEAR SAM SITE C-28 AS IT APPEARED ON [REDACTED] PHOTOGRAPHY.

A storage area (Figure 3 and 4) approximately 1,500 feet south of SAM site C-28 was first observed on poor resolution aerial photography on [REDACTED]. The entire area is probably fenced, though only a portion of the fence can be traced. A ground scar (Figure 1) extends northward from the area, crosses the C-28 launch area, and can be traced to a point just north of the railroad right of way where photographic coverage ends.

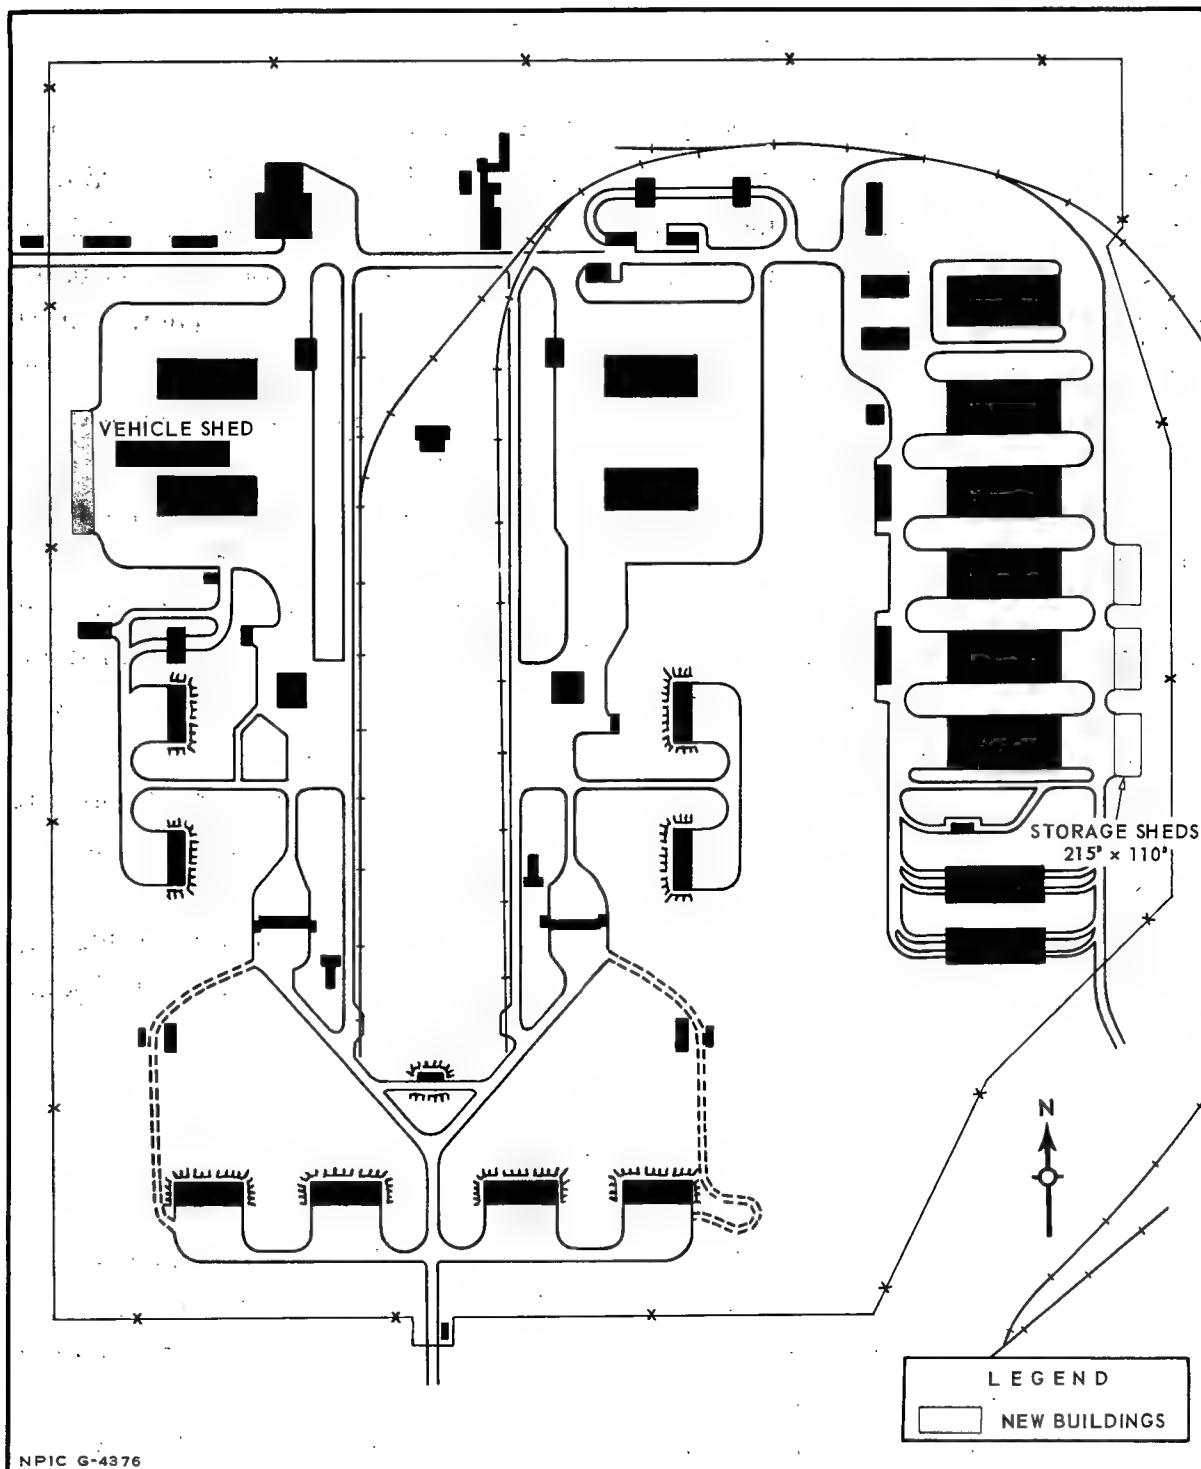
FIGURE 5. ISTRA MISSILE ASSEMBLY PLANT WITH NEW CONSTRUCTION INDICATED IN RED.

New construction in the plant area (Figure 5) was first observed on photography dated [REDACTED]. It consisted of foundations for three buildings, each approximately 215 by 110 feet aligned along the eastern side, and one building [REDACTED] feet along the western side of the area.

[REDACTED] two of the three buildings on the eastern side were roofed. The building on the west side was not covered by photography at this time but on [REDACTED] the roof appeared about 85 percent complete. By [REDACTED] the roof had been completed and the roof of the third building was 50 percent complete. The next photographic coverage, [REDACTED] revealed that all the buildings had been roofed.

All the buildings are gable roofed. The three on the east are probably storage sheds; the one on the west is evidently a vehicle shed since the east side of it is open and grease racks have been built nearby.

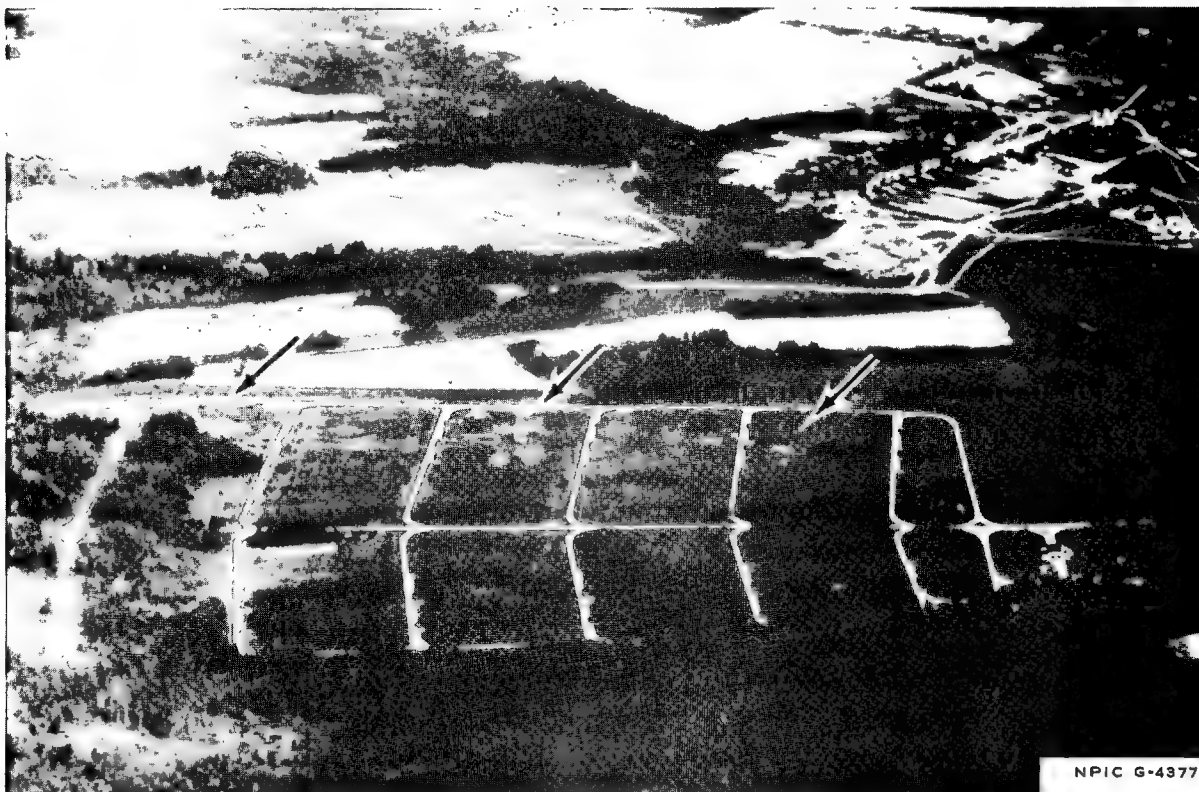
FIGURE 6. SAM SITE E-28. Photograph shows spherical objects as they appeared in [REDACTED]

New construction (Figure 6) was first observed at the launch area of Herringbone SAM site E-28 on aerial photography dated [REDACTED] It consisted of groups of foundations and spherical objects located at three separate places within the herringbone pattern. Each group was situated near one of the earth-covered bunkers that lies between alternate launch roads and all three were on the same side of the center longitudinal service road. However, one group of foundations, instead of being located between the large bunker and an adjacent launch road as was the case with the other two at E-28 and all those observed at C-28, was found between the bunker and the adjacent exterior longitudinal service road.

Oblique photography precluded a detailed examination but it was determined that two groups consisted of three spherical objects on foundations aligned close together, the other group consisted of two spherical objects on foundations and a foundation for possibly a third sphere.

25X1D Photography of [REDACTED] revealed that the spherical objects had been removed from at least two of the groups and that foundations similar to those found at C-28 remained. The third group was not covered by this photography. On [REDACTED] one of the groups observed on [REDACTED] was observed again and the spherical objects were still missing.
